Fuel saving by improving furnace door insulation

Location: A steel re-rolling mill, Bangladesh

Process: Steel re-heating furnace

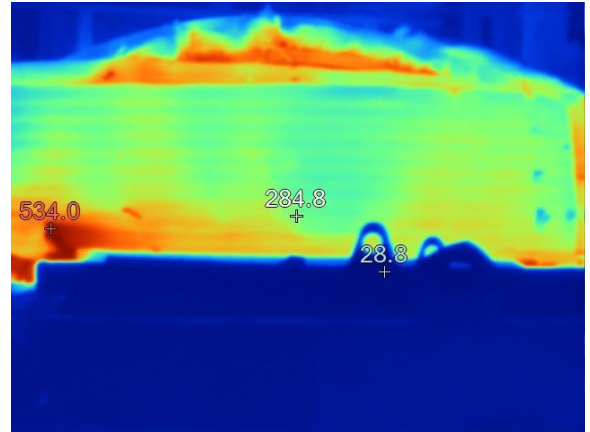
Before

- In reheating furnace, the furnace door was poorly insulated, resulting in high heat losses
- Temperature above 530°C was observed at the door surface
