# Power factor correction

**Location:** Swisstek Aluminum, Sri Lanka

**Process:** Fabrication unit

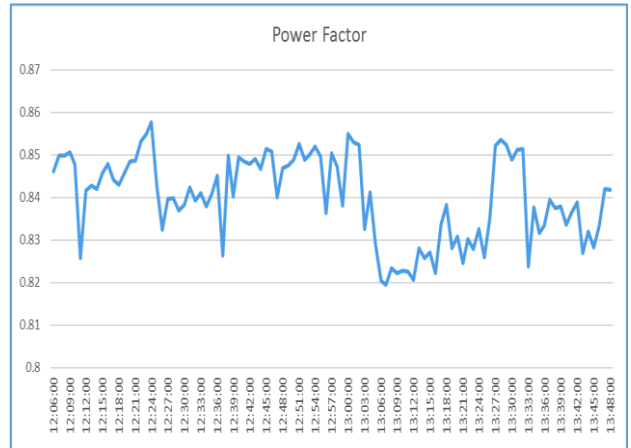
## Before

- Power factor maintained in the factory premises was low (0.84) leading to high demand charges
- Some of the capacitors in the capacitor bank were not operational
