# Drain out time increase in chemical treatment

**Location:** Energypac Ltd., Bangladesh

**Process:** Metal sheet fabrication

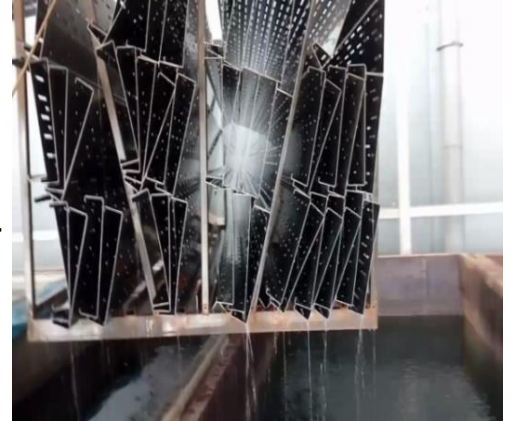
## Before

- Adequate drain out time was not maintained while removing fabricated sheets from chemical treatment tanks
- As a result, lots of chemicals and water were carried to the next process tank thus resulting in a diluted chemical mixture with acid / water loss
