# Paint spillage saving by installing collecting tray

**Location:** Galco Steel (BD) Ltd., Bangladesh

**Process:** Metal sheet manufacturing

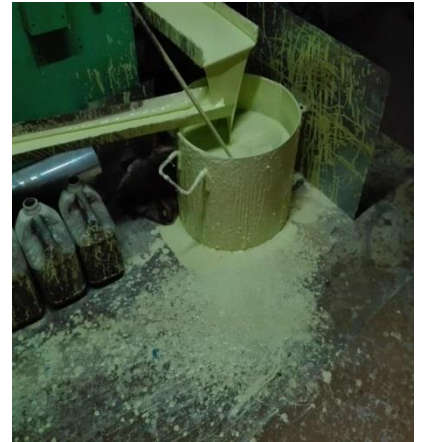
## Before

- The company used to lose around 1.6% paint due to spillage
- Around 950 L paint per day was used which included wastage in the color coating unit
- No collecting tray was installed on the floor to collect the spilled paint

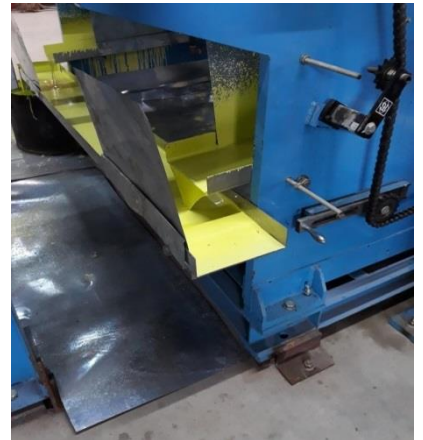
## After

- The company has installed new collecting trays below all color coating machines
- This has enabled the company to save around 4,600 litre paint annually
- Housekeeping in the color coating unit has also improved
